FINAL REPORT

***THE ACCIDENT INVOLVING THE CITABRIA
AIRCRAFT, REGISTRATION NUMBER E7-PDH,
WHICH OCCURED ON 31 DECEMBER 2022 AT THE
URIJE-PRIJEDOR AERODROME IN BOSNIA AND
HERZEGOVINA***

Edition: 1.0
Date: 31. March 2023
Marking: ACCID - 2/22

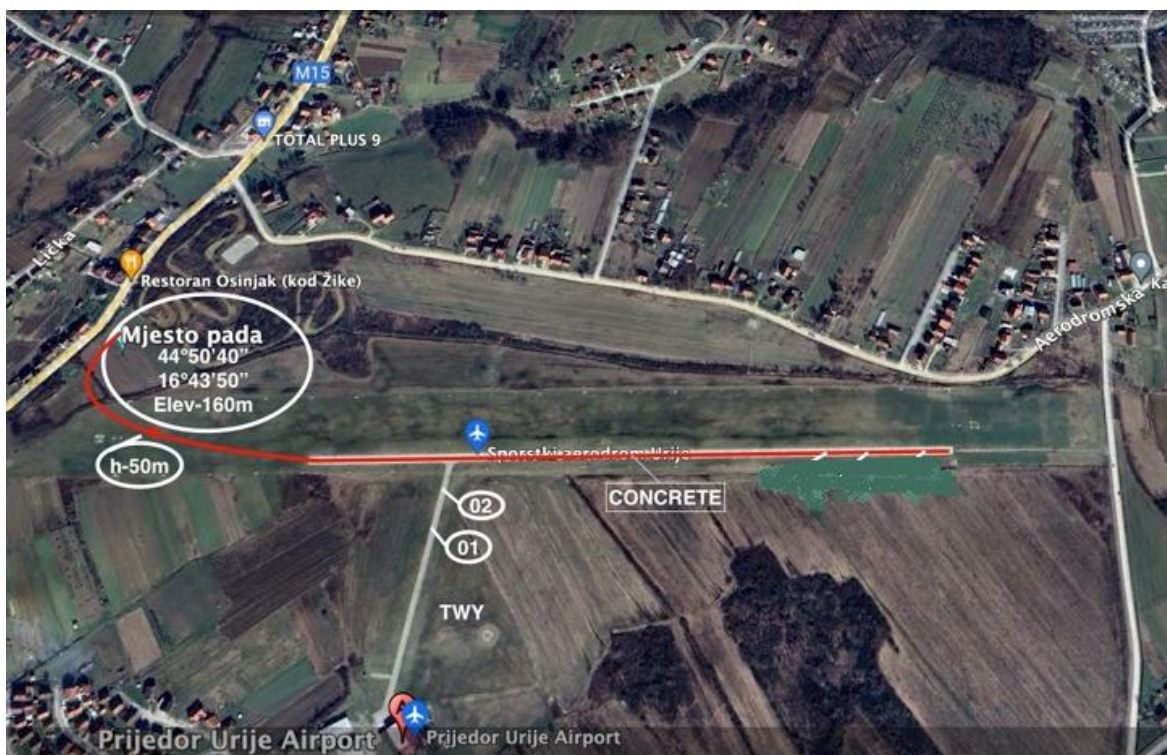
Picture 1.1: The aircraft's path, accident's site and locations of eyewitnesses

According to a pilot who was located at the taxiway at that time and witnessed the accident, the aircraft was at the altitude of 15 meters when it flew by the point where the runway and taxiway meet, which he considered was normal. After taking off and during a climb, the eyewitnesses noticed a minor instability in the aircraft performance. According to him as well as other eyewitnesses, at the end of the runway and at the altitude of approximately 40 to 50 meters moving at the angle of climb, the aircraft rapidly turned right. After taking a sharp right turn, the aircraft continued to roll over its right wing with the nose being more and more pointed to the ground, and then going into a steep, almost vertical dive. Before hitting the ground, the aircraft made a 270 degrees rotation. At the aircraft accident site, the aircraft longitudinal axis was pointed in the north-south direction, and the wings and main legs of the landing gear were in position parallel with the runway longitudinal axis. See *Pictures 1.1 and 1.2*.

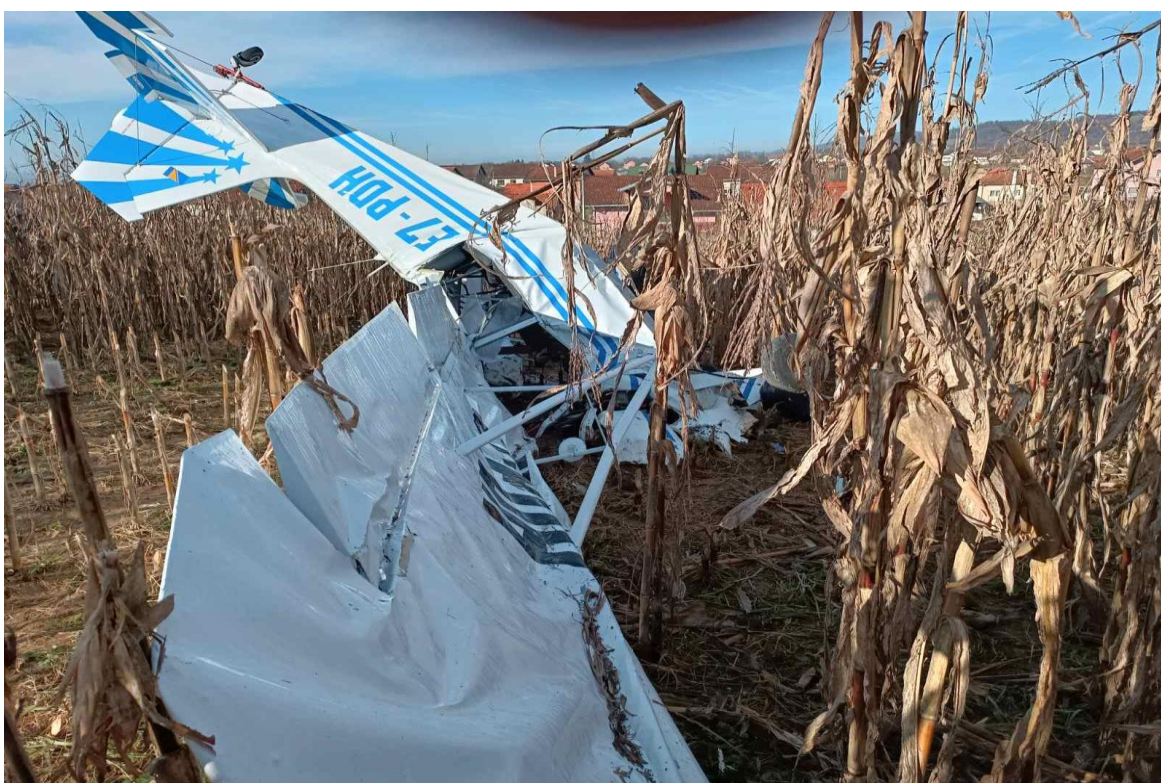
Picture 1.2: The position of the aircraft after hitting the ground (left side of the aircraft)

The aircraft crashed into the soft ground of a cornfield at a steep, almost vertical angle positioned somewhat to its back. The aircraft's nose struck the ground, whereby the propeller and engine plunged 40-50 cm deep into the ground leaving the pilot and the passenger dead and the aircraft completely destroyed. See *Picture 1.2*.

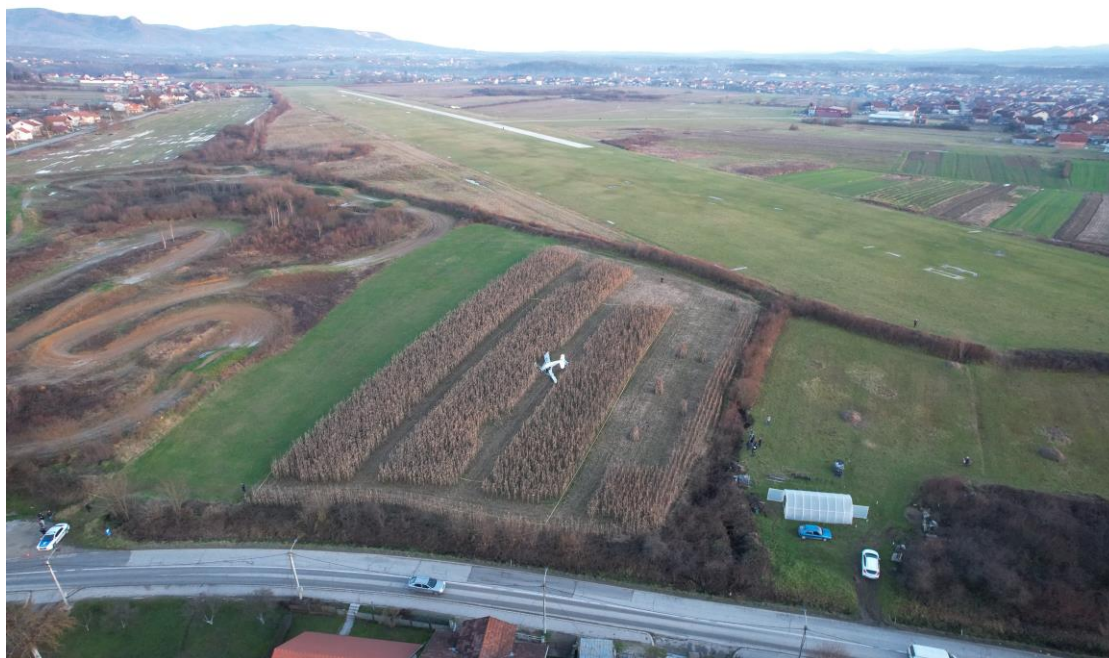
Picture 1.4: Accident site

The aircraft crashed north of the 09 PSS threshold, 98 meters away from the runway axis, that is 60 meters away from the runway's northern edge, and some 48 meters southeast of the main road M 15 Prijedor–Kozarska Dubica.

The aircraft accident took place on an agricultural land area, which is a field under 60-70 centimetres tall corn stalks. This is a soft surface terrain. To the north and

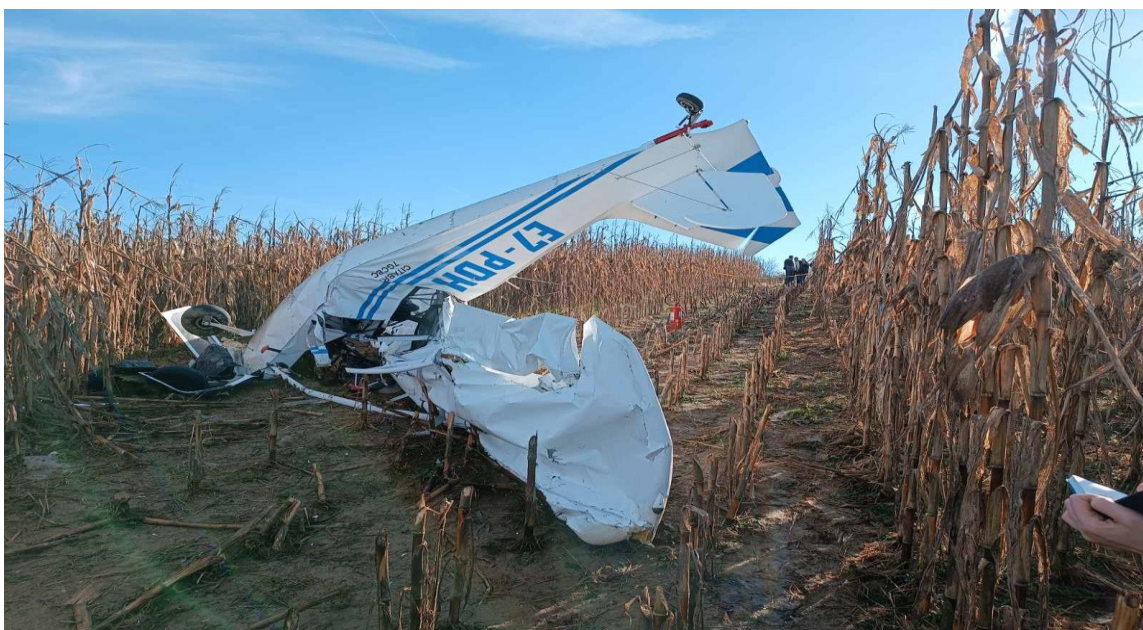
Picture no. 1.5: Position of aircraft after hitting the ground (the right side)

The force of the ground impact caused major irreparable structural damage to the aircraft. When the aircraft hit the ground, both wings were damaged in such a way that the front third of the wings got compressed, the fuselage immediately behind the passenger cabin suffered significant bending, and the engine, together with the engine mount and the propeller, stuck into the ground, leaning to the right of the axis. All parts of the aircraft were found at the accident site. *Picture number: 1.5*

The cabin, fuselage and the wing, particularly the right wing, were deformed significantly. The tail section of the fuselage and the tail surfaces (vertical and horizontal stabiliser) suffered minor damage.

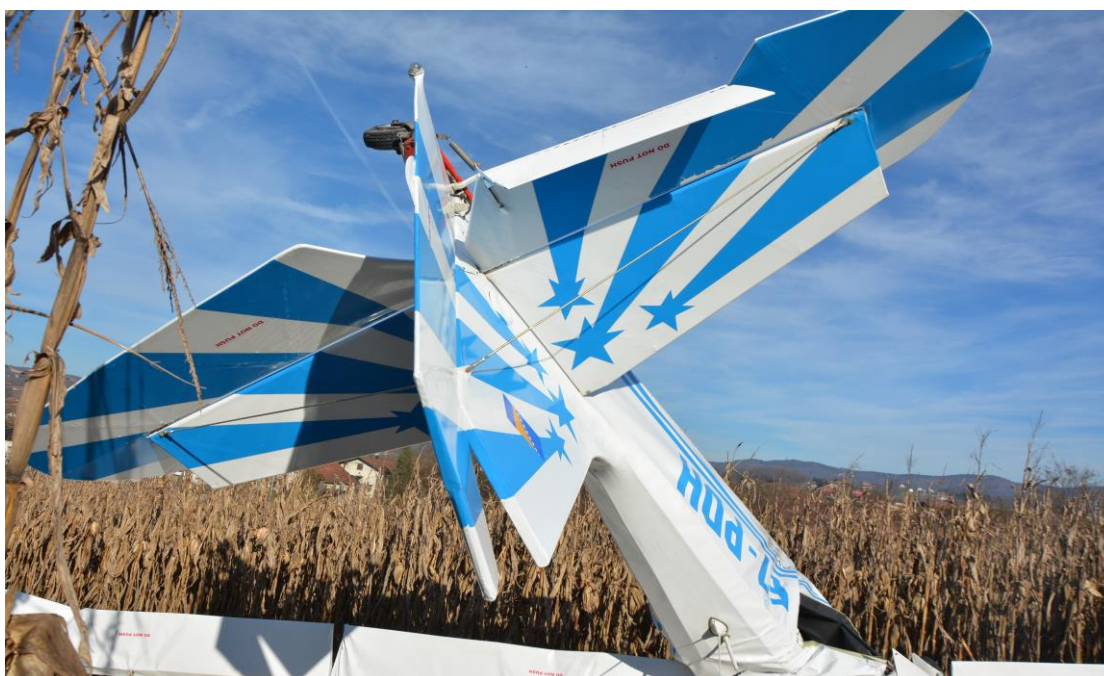
Picture number 1.6: Tail surfaces

An inspection of the depth rudder cables revealed that half of one cable strings were broken, while the other half were seamless and connected to the control stick.

The cables showed no signs of wear, but the strings cracking pattern resembled a broom, indicating that the cracking was due to very high stress, which probably occurred during the impact due to the blockade of the control stick, deformation of the fuselage at the location of the cable guide and inertial forces on the rudder.

The depth rudder was in the climbing position and the rudder was turned to the right. The flap was found in the retracted position. *Picture number 1.6*

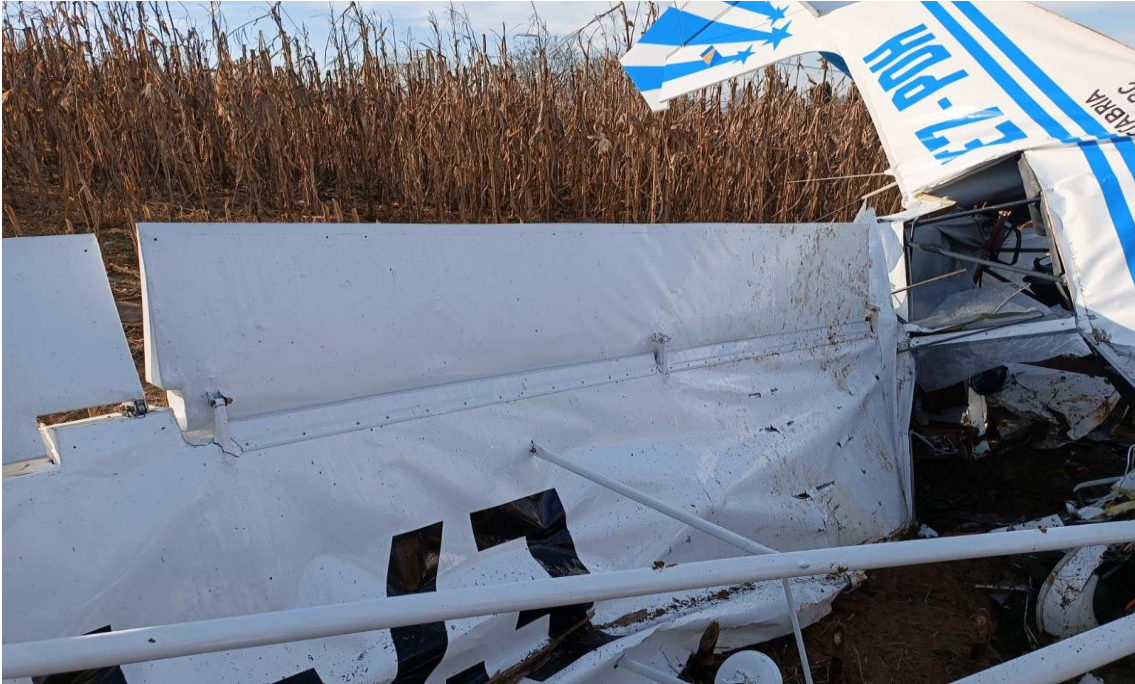
Picture number 1.7: Left wing and flap in retracted position

It was determined that the left wing flaps, which were less damaged during the accident, were not extended. *Picture number: 1.5, 1.6 and 1.7*

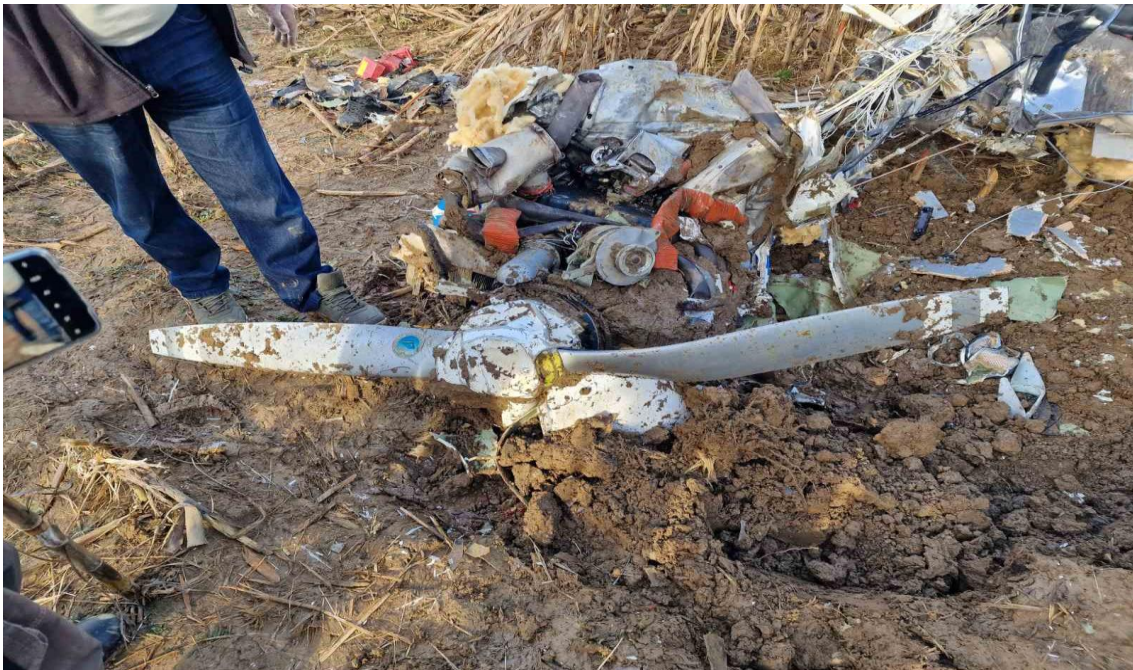
Picture number 1.8: Engine propeller

The engine and propeller were plundered into the ground to a depth of about 40-50 cm. After excavating the ground under the engine, a propeller was found with visible traces of rotation while it hit the soft ground where it suddenly stopped. The propeller deformations and visible scraping marks on the surfaces of the propeller suggest that the engine was running at the moment it hit the ground, meaning that the propeller was still rotating. *Picture number: 1.8*

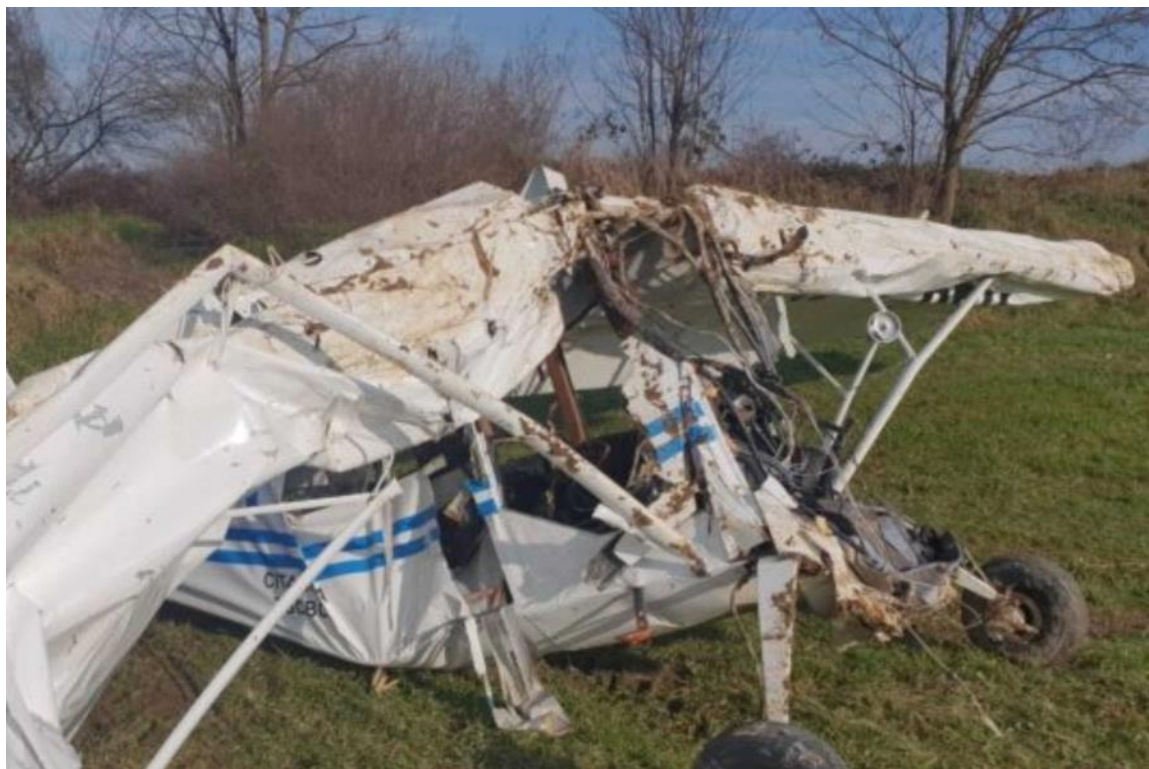
Picture number 1.9: Aircraft nose, wings and cabin

Due to fuselage deformation, the controls in the cabin were blocked and deformed. The throttle control was found in the 30% position, and the carburettor heating was on.

The pilot's instruments suffered extensive damage. The pointer was in such a state that nothing could be read, and no conclusion could be made.

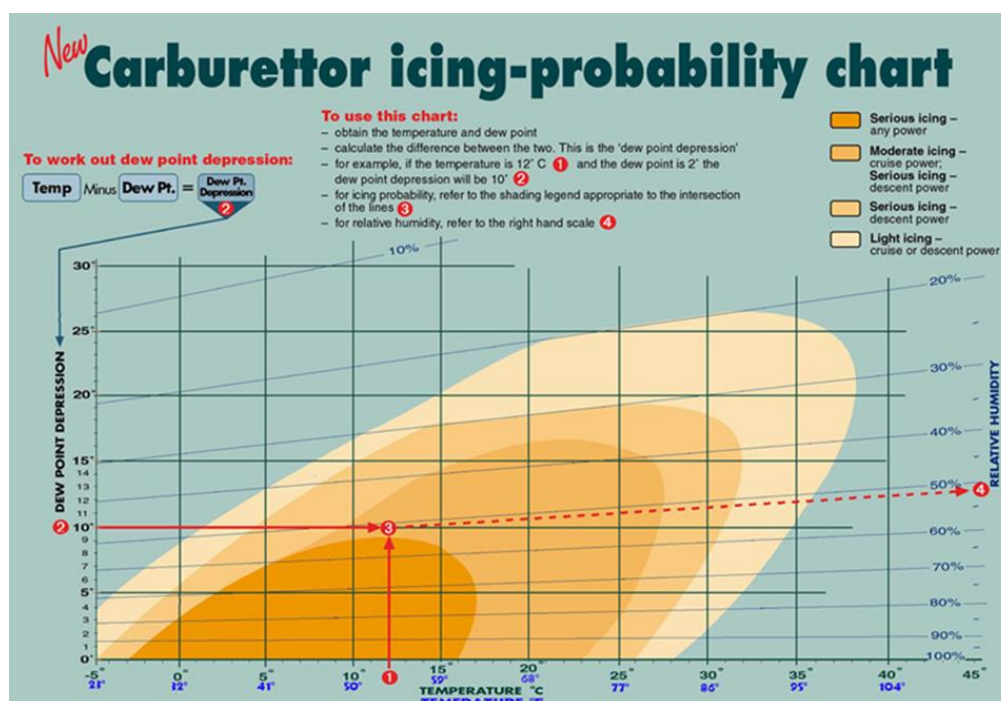
Graph number: 2.1: Temperature and relative humidity range that may cause carburettor icing.

and the pilot's actions. According to the available MET data sources, the air temperature and dew point (humidity) T/Td ratio was 18/9 and 18/8

Using the attached carburettor icing probability chart graph (valid for 100 LL gasoline) and available MET data, the probability of carburettor icing was moderate at 70% engine power (cruise). When gasoline is used, which is more susceptible to icing (STC), the probability is serious and possible at power engine climbing. It is not known whether the pilot used this method. (STC for gasoline states that due to higher volatility, MOGAS is twice as sensitive to carburettor icing compared to AVGAS and that this is a mandatory procedure in pre-flight preparation).

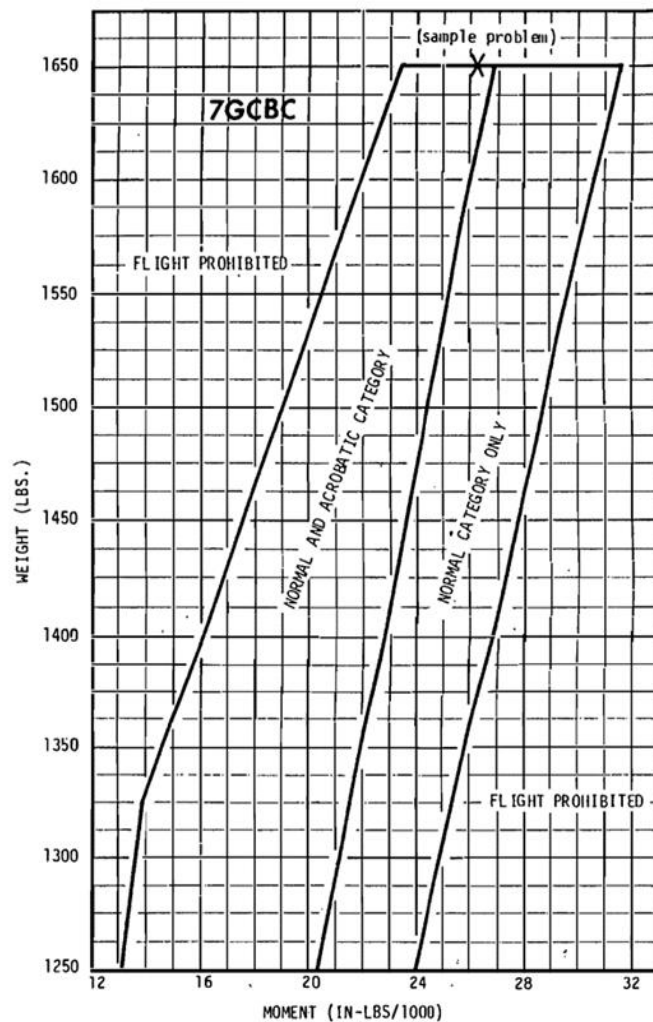
FIGURE 5-5 FLIGHT ENVELOPE - 7GCBC ONLY

Based on the estimated weight of the pilot (100–110 kg), passenger (70–75 kg) and gasoline in the tanks (75 kg), the aircraft had a total pre-flight weight of 786–801 kg (1734–1767 lb), 38–53 kg more (84-117lb) than the maximum permissible weight.

The maximum permissible pre-flight weight is 1650 lb. the pilot took off with the total pre-flight weight that was beyond the flight envelope limits.
